Draft Resource Management Plan

Chestnut Hill Reservation

Boston, Massachusetts

March 22, 2006

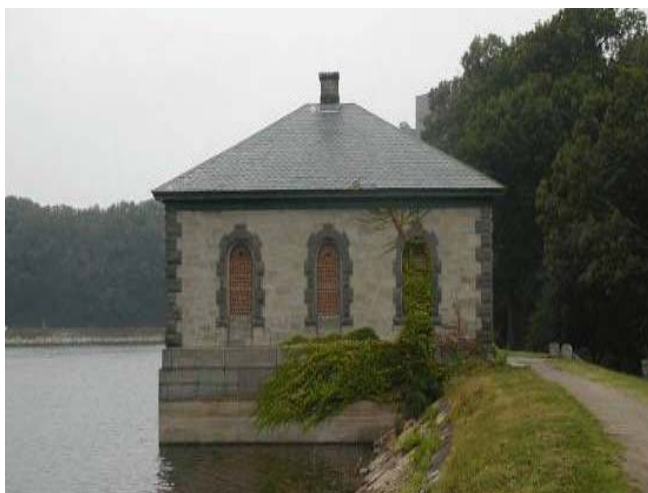
Figure 3.8: Gatehouse #1 upper structure (2005)

The 2005 field examination did not include the lower level; an attempt was made to reach the upper level through the lower level but the wood platforms, catwalks and stairs were heavily damaged with rot and corrosion and access over the water-filled chambers was too dangerous to attempt. An extensive survey of the upper and lower interior levels was conducted by GZA GeoEnvironmental Inc in 1998 and their March 1998 report¹³ can be consulted for a description of the chambers and related elements.

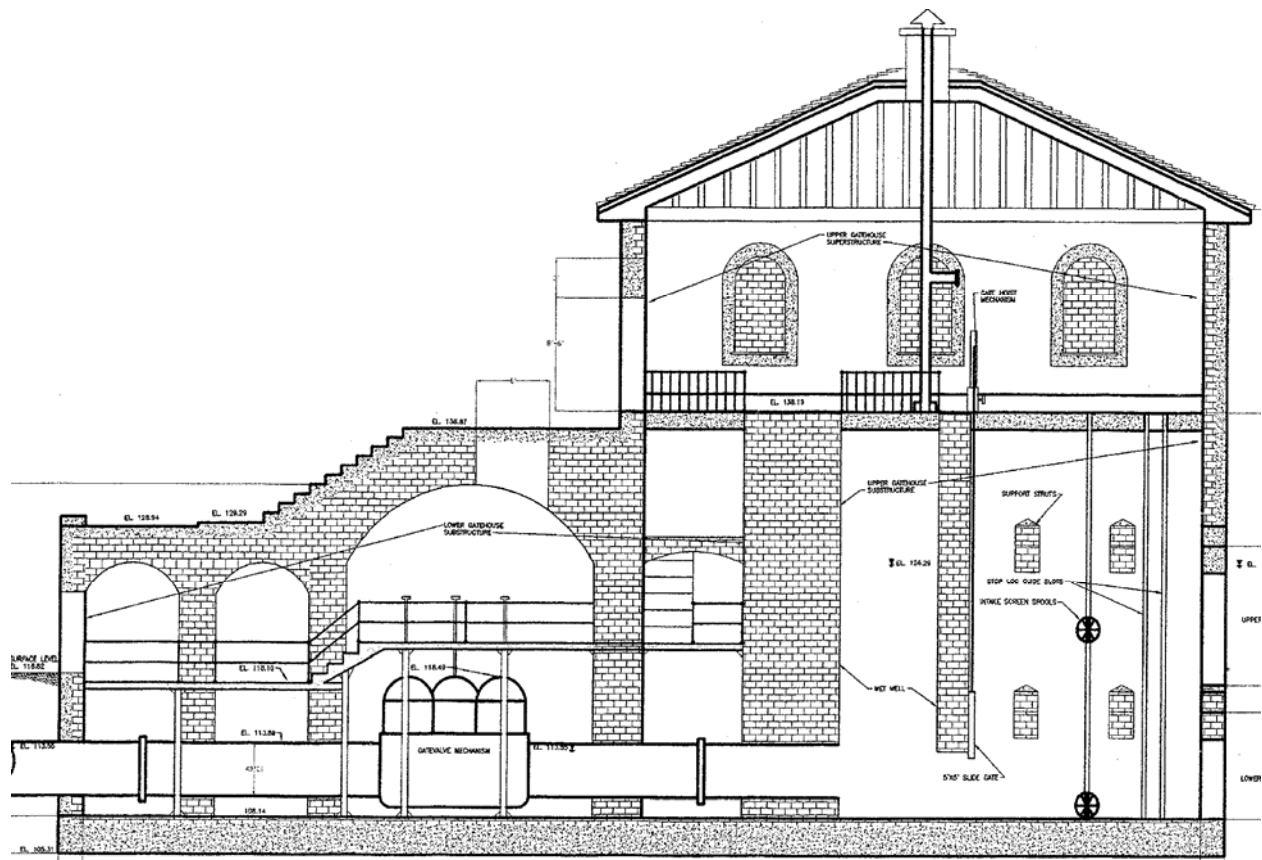
GZA's 1998 report for the MDC studied options and issues related to the use of the gatehouse. Based on the GZA report, if Gatehouse #1 was to be open to the public in some form, it would be necessary to close the chamber in the lower part of the structure with fill (either flowable concrete fill or a mix of flowable fill and crushed stone) and to

Figure 3.10: Section of Gatehouse #1 from GZA GeoEnvironmental, Inc. report

concrete up to the upper floor elevation of 138 feet. Bulk heading of the intake and outtake pipe would also be necessary. GZA estimated the cost of closure (which included the work described above plus limited re-pointing of the exterior stone masonry of the gatehouse from the normal water line to the dam crest elevation, construction phase resident engineering, and preliminary testing for lead paint within the lower part of the gatehouse) at between \$233,000 and \$288,000 (at 1998 prices).

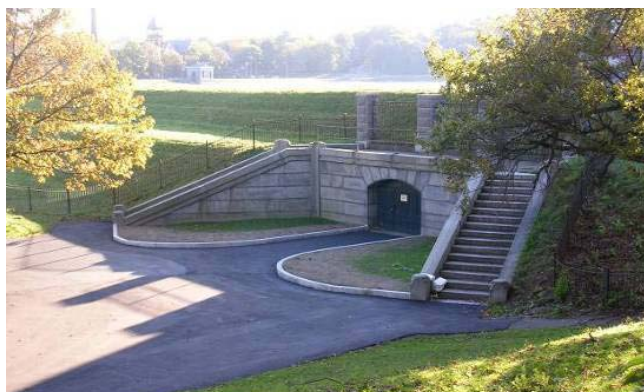
Figure 3.11: Gatehouse #1 lower structure and double stairs (2005)

Each stair consists of individual tread stone units and heavy side wall units. While the stairs appear to be in good condition, there is evidence of past movements among the various stone units. The side cheek walls appear to have tilted or shifted laterally, creating wide gaps between units that were subsequently filled with mortar. The wide mortared joints are generally intact but many are cracked.

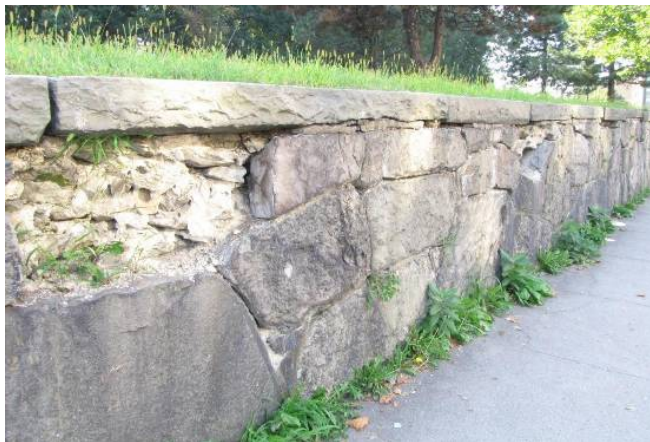
Figure 3.15: Stone retaining wall along Chestnut Hill Avenue (2005)

The stones are mortared together and the mortar between stone units is generally cracked, missing, disintegrated or is an inappropriate white mortar color used for a previous re-pointing. In spite of the mortar deterioration, the large size of the stone units has ensured the stability of the wall, there being no significant displacement of the wall as a system or of most of the stone units individually. However, several cap stones at the curve in the retaining wall near Commonwealth Avenue have been displaced outward about six inches. Also, small stones at the surface have toppled out of the wall at roughly ten to fifteen foot intervals.

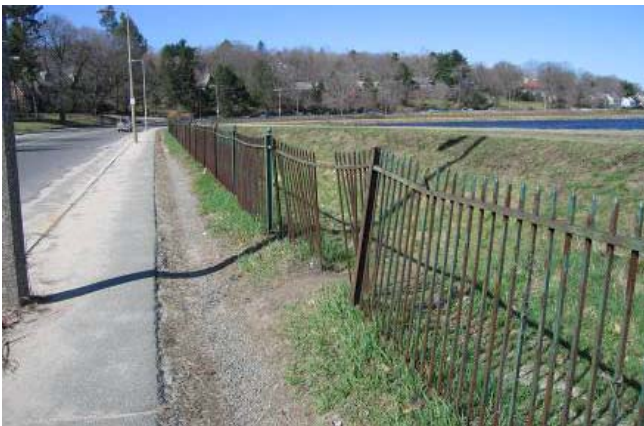
Figure 3.26: 1928-29 steel picket fence (2005)

The condition of the fence was analyzed in 2004 by DeAngelis Iron Works and, in 2005 as part of this RMP, Ocmulgee Associates performed a further inventory and evaluation. According to Ocmulgee, the 1928-29 steel picket fences are extensively damaged, with many deteriorated and missing elements. In particular, the following items were noted:

- The paint is completely deteriorated and some of the pickets are pitted from corrosion;
- Ten percent of the top rails are bent;
- Fifty percent of the pickets are bent or corroded in some degree, with about ten percent severely bent, missing or corroded;
- Forty percent of the panels have bottom rails that are significantly corroded and unsalvageable due to being buried in earth or vegetation;
- Twenty-five percent of the panels are in reasonably good condition and can be easily repaired;
- Thirty-five percent of the panels are in mixed condition, having damage and deterioration that could be repaired with replacement components;
- The posts appear to be set in concrete but many are corroded to some extent near the ground. Less than ten percent of the posts have broken off at the ground.

If parts of the perimeter fence are judged unnecessary and removed, sections that are in the best condition should be reused to replace deteriorated sections in other areas of the Reservation. This will help reduce the repair costs and maintain the integrity of the original material. In accordance with the 2002 MDC-MWRA agreement, sections of 1928-1929 fence not used at Chestnut Hill Reservation should be made available to the MWRA to repair similar fencing at other locations.

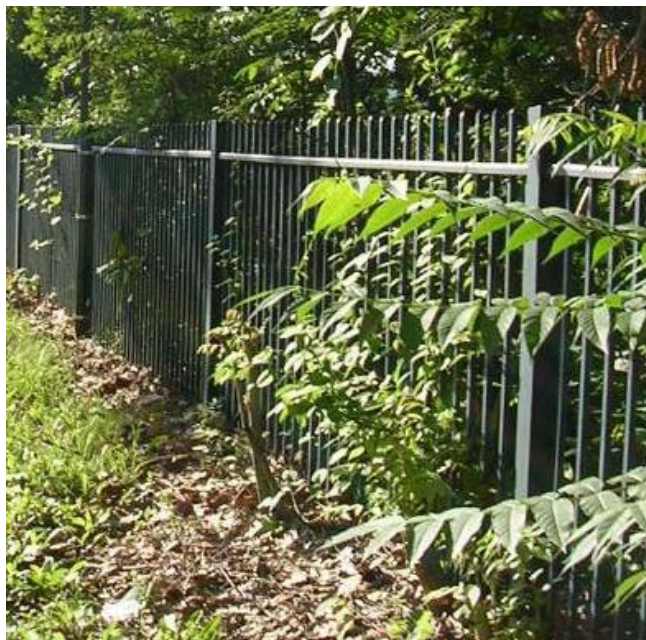
Figure 3.30: 1977 steel picket fence (2005)

The 1977 fencing panels are in fair to good condition except

for some vine growth on certain sections, although preventative measures should be taken soon to ensure the continued condition. There is one panel near the modern stone wall that appears to have had damage repaired inserting in a section of salvaged, unpainted 1928-1929 fencing.

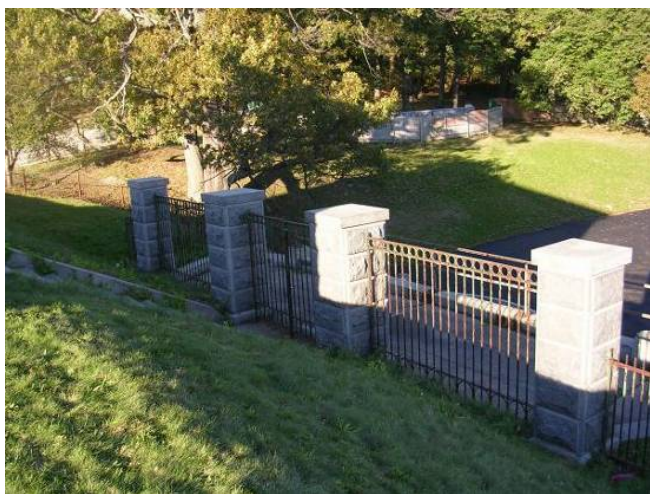
Two 1928-29 gates are located in front of the two gatehouses. The two forty-seven inch wide gate leaves and the ten foot six inch long fences on each side of the approach to Gatehouse #1 are about six feet high and are decorated more elaborately than the typical panel. Except for extensive paint loss and some corrosive pitting, they are in excellent condition. Most importantly, their hinges and anchors at the granite posts are intact and no spalling or deterioration was seen where the metal anchors are embedded in the stone. Similar gates but no side fences are present at Gatehouse #2; some of the decorative circular elements are missing at these gates.

Figure 3.31: 1928-1929 entrance gate at Gatehouse #1 (2005)

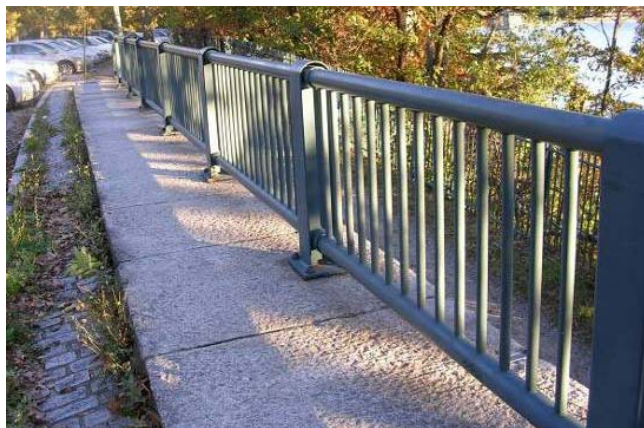
A heavy-gauge pipe rail fence, installed in 1977, spans the top of the retaining wall along Chestnut Hill Driveway. Its

design consists of panels of seventeen balusters attached to round horizontal bars at top and bottom between I-section posts with arched tops. It is painted green and remains in good condition.

Figure 3.34: 1977 fence on top of Chestnut Hill Driveway retaining wall (2005)

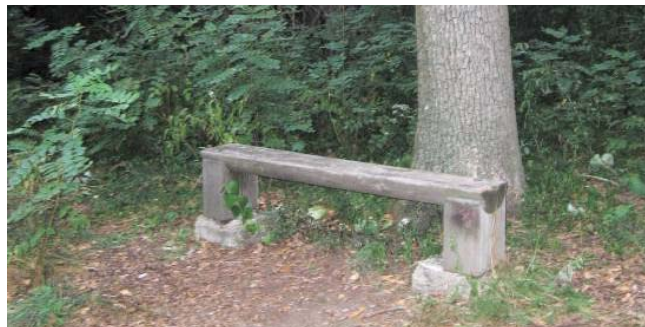
Figure 3.36: Type 2 bench (2005)

The second bench (Type 2) has a more rustic design and consists of a longitudinally cut log fixed on rectangular wooden legs. The legs are secured to concrete blocks which are now exposed several inches above the grade of the soil. There are ten (10) these log benches in the Reservation:

Generally, these benches are in poor to fair condition with some severely deteriorated and nearly falling over due to exposed footings. These benches are not visually attractive or appropriate for an urban park setting.

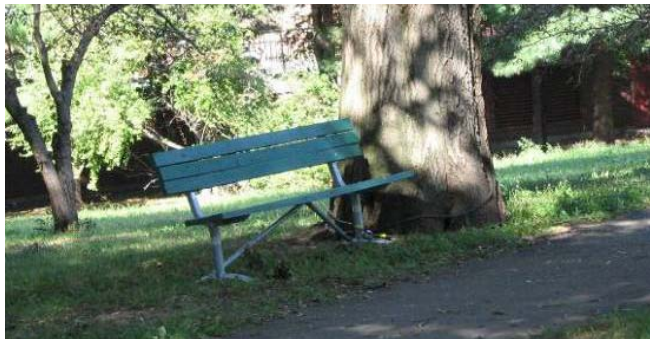
Figure 3.37: Type 3 bench attached to tree (2005)

The Type 3 benches are in fair to good condition, but are not an appropriate style for the Reservation, because they are not permanent installations and as mentioned above, the security cables damage the trees and fence.

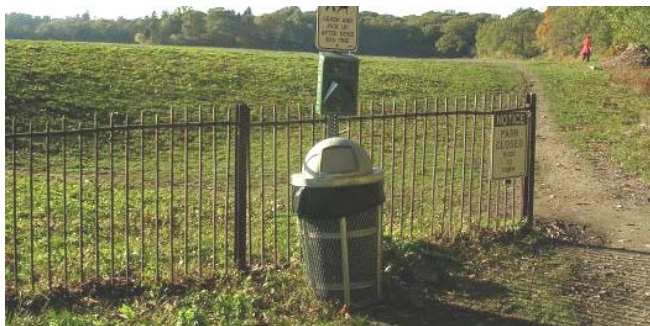
Figure 3.38: Trash receptacle and pet station (2005)

Two steel mesh trash receptacles are currently located at the entrance from the old playground and at the entrance near the intersection of Chestnut Hill Driveway and Saint Thomas More Road. Both are in relatively good condition. Adjacent to these two trash receptacles are dog scoop bag dispensers. A steel drum is located in front of the bituminous path to the Rink from Beacon Street that functions as a trash can. It may be that, for park users, a better location for trash receptacles would be at major entry

or exit points to the Reservation. Certainly their current location means that DCR personnel must drive vehicles over pedestrian paths to access the receptacles for emptying; placing them at major gateways which are adjacent to roadways would result in less potential damage to pedestrian areas.

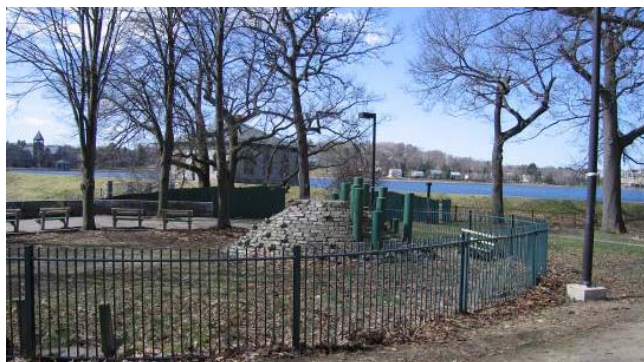
The 1977 MDC landscape improvements included the construction of a children's playground in the area between the Reilly Rink and the Reservoir. The play equipment has since been removed, although a stone mound remains that is a remnant of the slide play structure. The only remaining functioning feature is the semi-circular seating area with six benches facing the parking lot in front of Gatehouse #1. The stone retaining wall on the south side of the playground remains in structural good condition, although it is covered in graffiti.

Figure 3.39: 1977 playground (2005)

The dilapidated playground and graffiti-covered retaining wall are prominent eyesores in the landscape. The stone mound may be considered a safety hazard for children tempted to play on it. There seems little need to restore the area to a functioning playground: there are similar children's playgrounds provided in nearby parks such as Boyden, Shubow, Joyce and elsewhere, and seemingly little local demand for further play space for younger children.
